After the expiry of the building rights agreement, the pavilion reverted to the City of Zurich in 2014. A feasibility study conducted by Silvio Schmed and Arthur Rüegg in 2015 identified three major problem areas. First, the building envelope was no longer leakproof, affecting both the concrete of the basement and the ramp, as well as the neoprene seals in the glass façade. Rust was eating holes in the sheet metal. The paint coatings of the steel umbrellas contained toxins 250 times higher than the permitted level. Second, the infrastructure was defective. As a result of corrosion, the underfloor heating had not functioned since 1982, and the climate in the basement ruled out exhibiting any originals. The electrical system was also in a desolate state of repair. Third, the pavilion no longer complied with standard architectural practice. Since the 1965 building permit was still valid, however, the elaborate restoration could focus on the first two problem areas. Replicas were made of the wooden furniture and the tree tables, and the marble table was replaced by a Cassina model. The pavilion reopened in 2019.

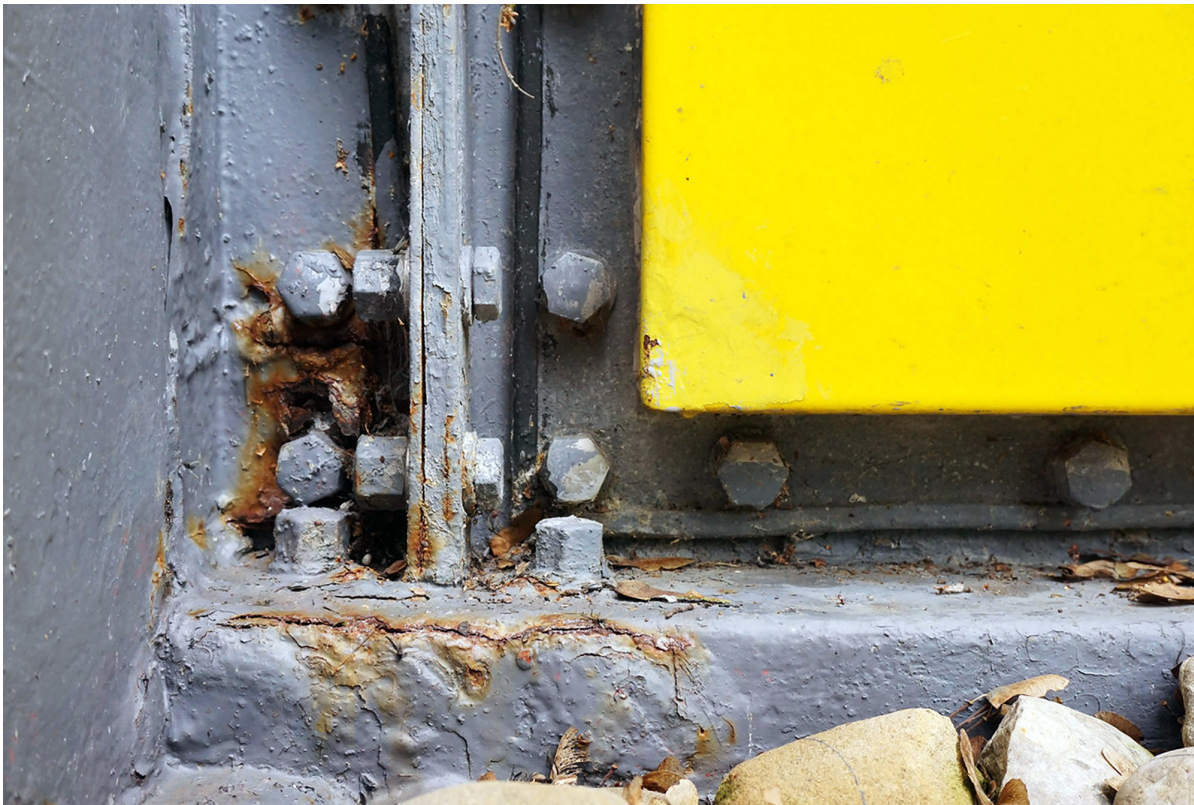
Corrosion damage at the base of the building before the 2018 restoration, Pavillon Le Corbusier
